## CARGO BARRIERS AND RESTRAINT STRAPS

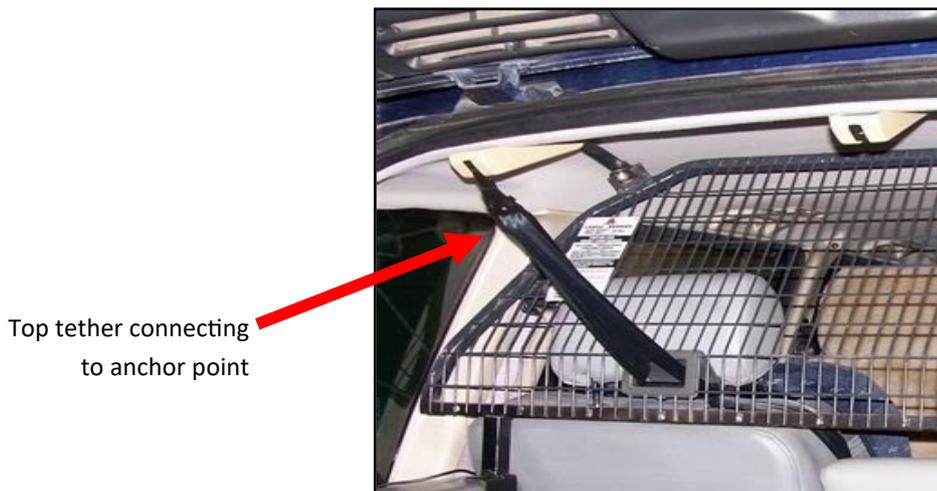
In many wagon, 4WD and Hatchback type vehicles, you will find that a cargo barrier is installed right behind the back seat and the top tether strap from the restraint will need to pass through the cargo barrier in order to connect to the anchor point or anchor hook, similar the photo below:

You should **NEVER** force the top tether or any strap through the normal small openings of the cargo barrier and a wide opening should be created with a rubber or plastic coating around the inside of the opening in order to provide a smooth path for the strap to follow and cause no damage to the strap.

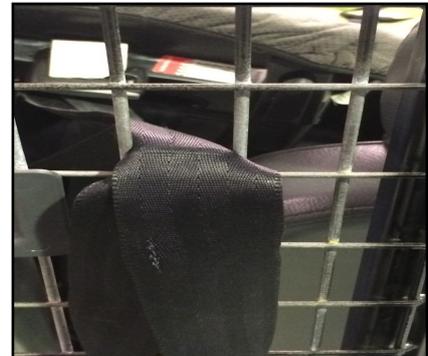
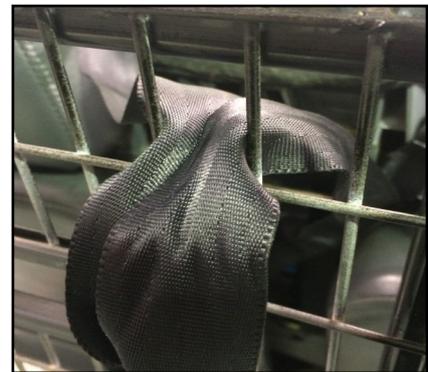
## DONT's

If the strap does not have this smooth path, then the vibrations of a car will wear through the strap very quickly. We have seen straps that are forced through cargo barriers fray and deteriorate in less than 3 months. A small fray or cut in your strap means it is potentially dangerous and cannot be used. In most cases, the individual straps cannot be replaced or repaired, meaning that you will have to dispose of your child or disability restraint and purchase a new one.

We have provided some images of what **TO DO** and what **NOT TO DO** on the next page for further guidance.

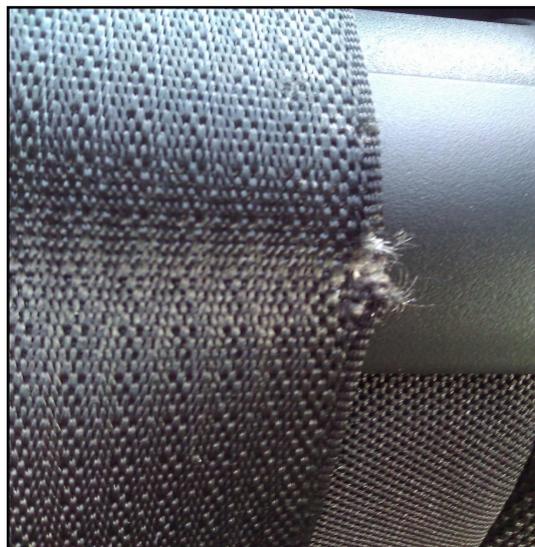
EXAMPLE OF A FRAYED STRAP FROM A CARGO BARRIER THAT **CANNOT** BE USED
